# Manhole Inspection Summary

Manhole # S21UU1024MH

Insp Date: **5/4/07 1:00 PM**

**Location** Address: **HAMIL RD**

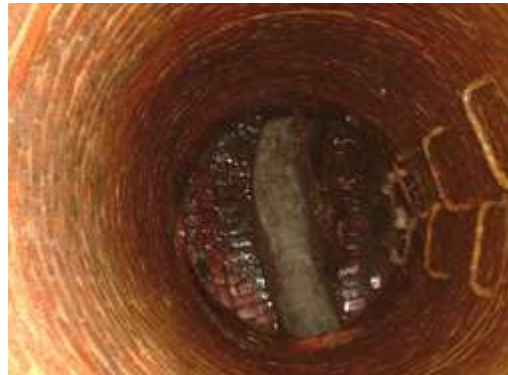
Top View

Count: **14** Missing: **0** ☒ **Corroded**

☒ **Evidence Of Surcharge**

Corroded steps. Evidence of surcharge - Bench debris.

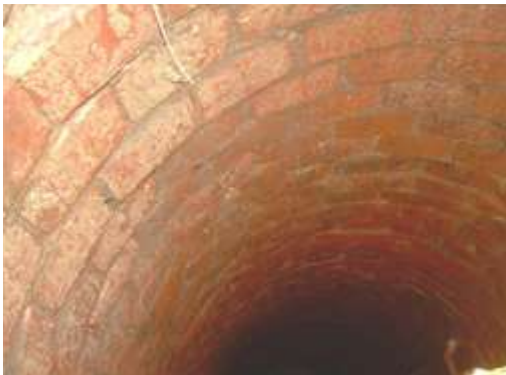
Defect

Infiltration: ☐ None ☒ **Joint** ☐ Cracks ☐ Mortar ☐ Roots ☐ Wall

Infiltration: ☐ None ☐ Joint ☐ Cracks ☒ **Mortar** ☐ Roots ☒ **Wall**

Corbel root intrusion and infiltration.  
Barrel infiltration.

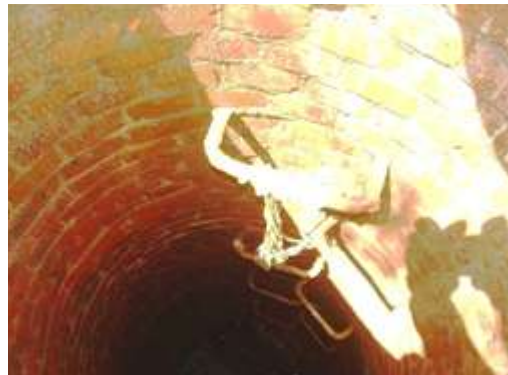
Defect

Corbel and Barrel infiltration.
